CLEMENTON LAKE DAM

NJ 00410

PHASE 1 INSPECTION REPORT NATIONAL DAM SAFETY PROGRAM

May, 1979

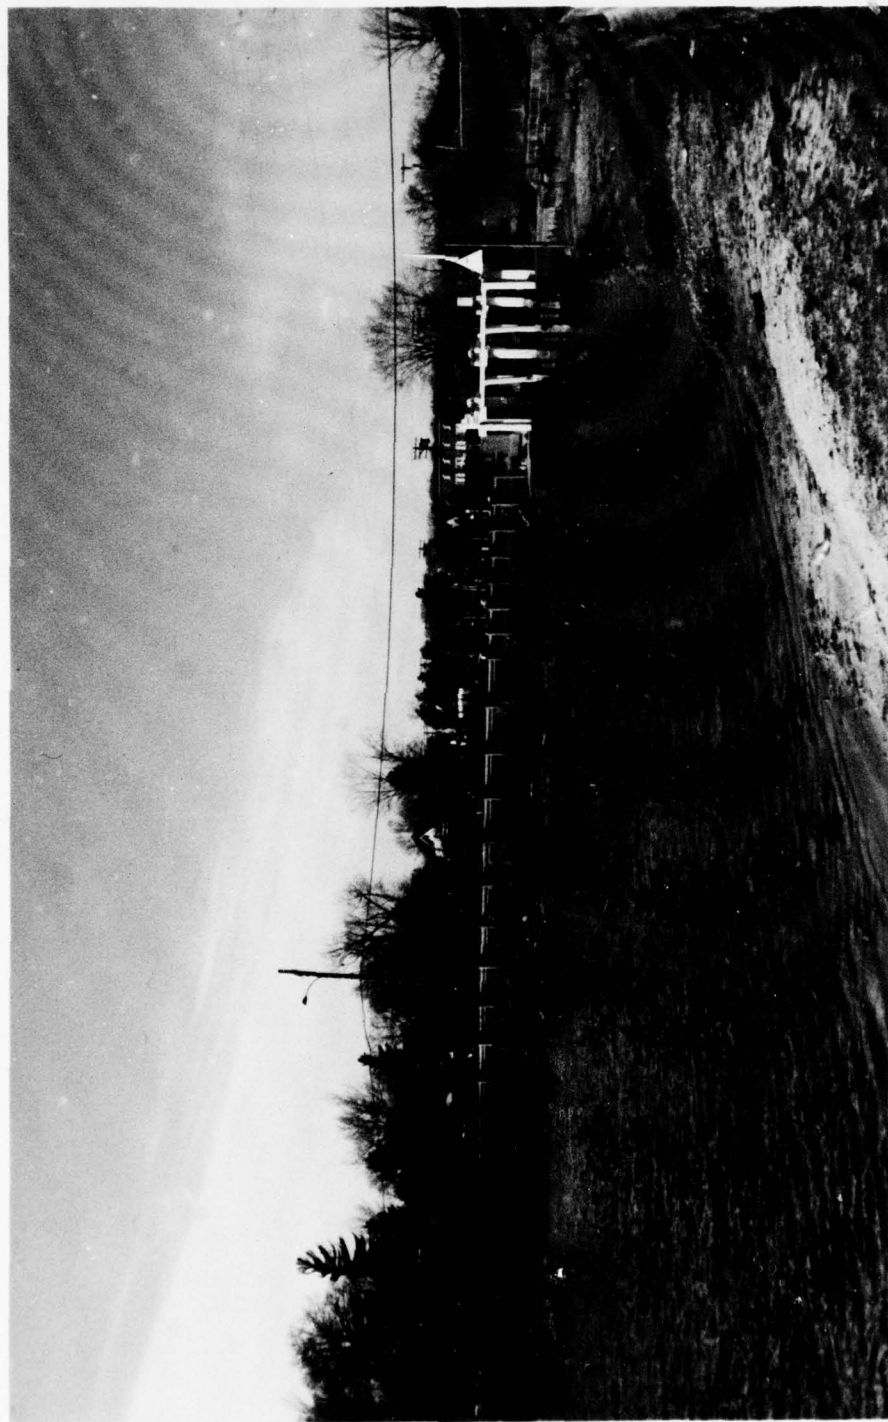
OVERVIEW - CLEMENTON LAKE DAM

Clementon Lake Dam is in good overall condition, and outwardly structurally stable, however the hydraulic capacity of the spillway is inadequate. The SDF (Spillway Design Flood) for Clementon Lake Dam is 1/2 PMF. The spillway at the dam is capable of passing approximately one percent of the PMF without overtopping the dam.

- 1) All trees and brush on the embankment should be removed with minimal disturbance of the ground surface.
- 2) Eroded areas and the broken and cracked roadway pavement on the upstream slope of the dam should be repaired. Riprap should be placed along this slope to protect it against wave attack and drainage induced erosion.
- 3) The timber spillway and the bridge should be thoroughly inspected. Rotted timbers should be replaced and cracks and spalling in the bridge structure and wingwalls should be grouted and sealed.
- 4) The opening observed in the stone drywall southwest of the bridge should be inspected and repaired.
